# Manhole Inspection Summary

Manhole # S29CC\_023MH

Insp Date: **6/23/08 3:30 PM**

**Location** Address: **1205 DIVISION ST ALLEY**

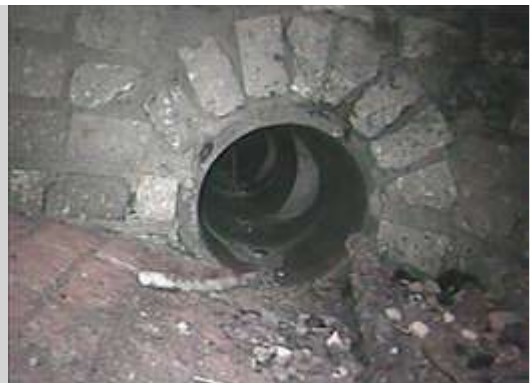
12 O'Clock Outflow

8 in. Circular Gravity Sewer  
Pipe Out @ 12 O'Clock

Pipe Material: **Clay** ☐ Pipe Lined

Invert Depth: **7.71** (ft.) Flow Characteristics: **None**

Deposits: ☒ None ☐ Mud ☐ Sludge ☐ Debris ☐ Grease

Infiltration: **None** Pipe Seal Cond: **Sound**
